Home Inspection Report

Inspection Information

Inspection Date: 01/06/2018.
Client Name: [REDACTED].
[Client Email:](#) [REDACTED].
Inspector: [REDACTED].
Individuals Present: Buyer, Family and Broker.
Outside Temperature: 5-10F.
Ground Conditions: Snow Covered.
Current Weather Conditions: Clear and Cold.
Past Day Weather Conditions: Clear and Cold.
Inspection Conditions: Vacant Property.
Inspection Start Time: 9:00 AM.
Inspection Finish Time: 1:30 PM.
Inspection Type and Cost: Single Family Home Inspection: \$ [REDACTED].
Radon Test: Radon Vials: [REDACTED], Vial Numbers: [REDACTED].
Other Services Provided: None.
TOTAL AMOUNT DUE: \$ [REDACTED].

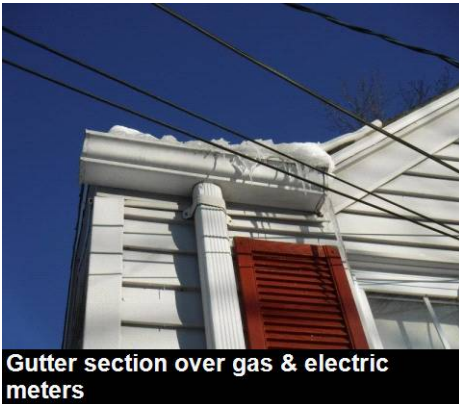
The roof is snow covered with a heavy build up of ice at the eave/gutter areas. The ice damming has lead to ice running down the siding of the house as well as water entry at the rear sill area. Ask for all ice damming history and consider further evaluation by a qualified contractor to identify the source/cause of the ice damming as well a a course of action.

Gutter section over gas & electric meters

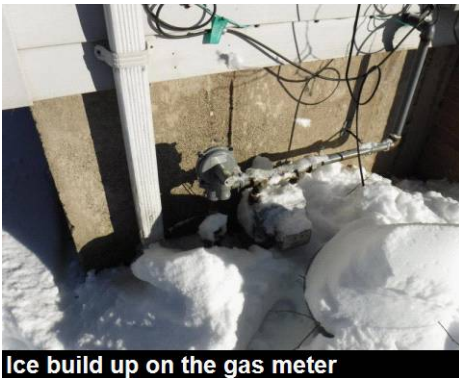
Ice build up on the gas meter

Consult the local Natural Gas Provider regarding protective devices to limit ice build up on the gas meter and associated equipment.

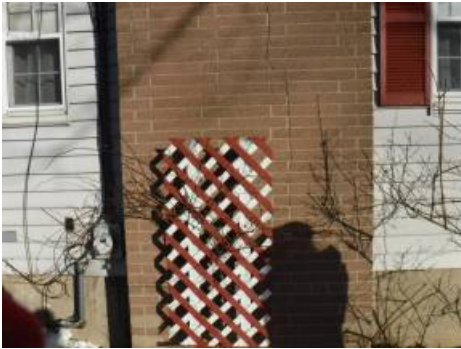
The chimney is constructed of concrete brick. There is a vertical crack running from top to bottom and smaller cracks off to the side of the larger crack. Consult a qualified mason to evaluate the chimney for the cause of the cracking and the extent of repair that is needed. Consider installing screened chimney weather cap. This will prevent water penetration and rodent/bird entry.

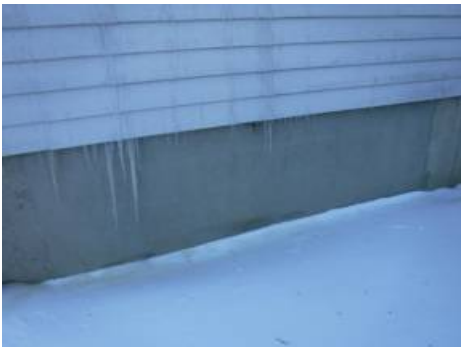
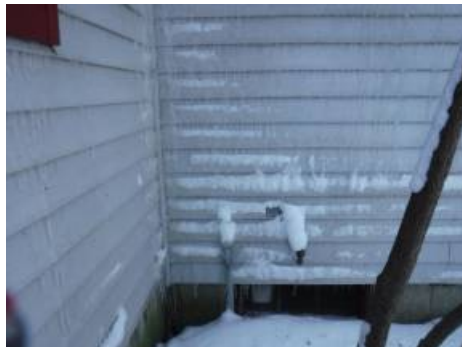
Seal random holes in siding or replace with new sections. Siding penetrations should be installed with proper methods including mounting blocks and proper channel around it. Ice and water noted on siding under areas of ice build up at the eaves.

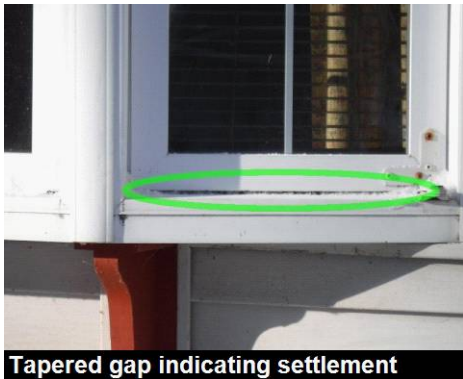
Type: Vinyl Trim, Metal Wrap (condition of the material covered is not accessible), Wood Trim and Brick
 Paint random areas of wood trim.
 The rear bay window has settled as indicated by the tapered gap at the window top and bottom. Adjustment/repair makes for a better fitting and operating window.

Tapered gap indicating settlement

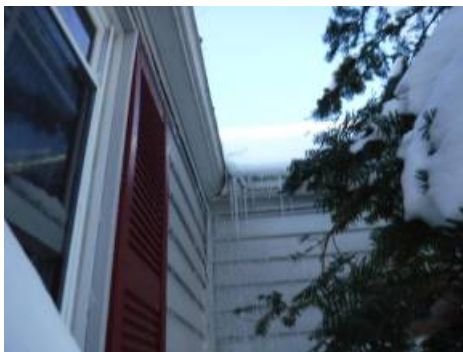
Type: Aluminum Gutters with Aluminum Downspouts
 There is bulging of downspouts and staining on gutters indicating a history of blockage and over flow. The gutter and downspout system needs to be fully cleaned out, adjusted to drain and then regularly maintained.
 Limited access to gutters and downspouts at this time due to snow and ice build up.

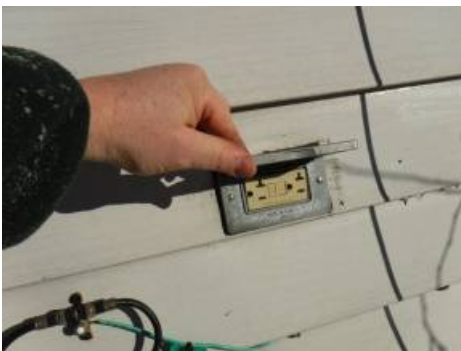
Condition: GFCI outlet did not respond to tester. Evaluate and repair/upgrade faulty GFCI outlet. Upgrade all exterior outlets to properly functioning GFCI outlets.

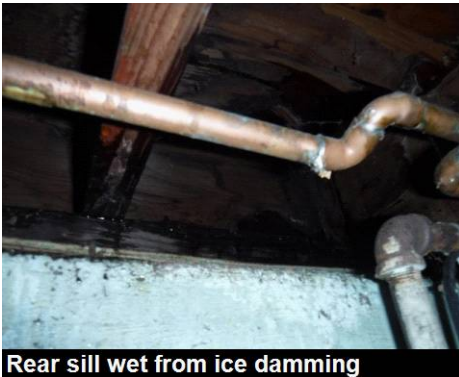
There is active and flowing water entry into the basement and crawlspace at the rear sill that appears to be the result of ice damming. Investigation and repair is needed.

Rear sill wet from ice damming

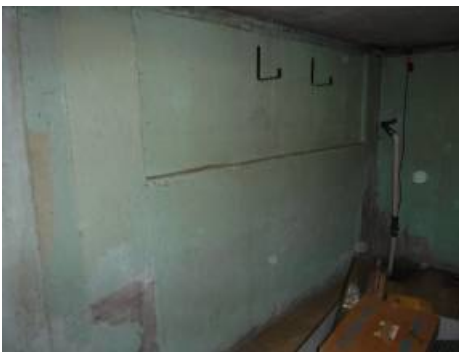
Type: Concrete
 It appears that the left end of the front foundation wall had an opening for a garage under.
 There is a visible cold seam at the rear foundation wall that has no visible signs of movement or change.

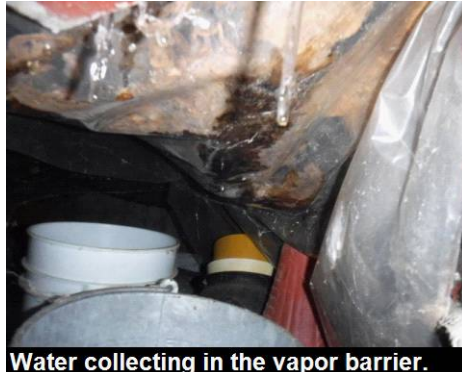
Water collecting in the vapor barrier.

Condition: *How Viewed:* From Opening. Exterior snow build up and smaller access opening limited inspection to visual observations from the opening.
 There is active water entry into the crawlspace and collecting in the stapled up vapor barrier. Water entry appears to be from ice damming at the rear valley/eave, window with an AC unit installed and clogged gutters.
 Remove failing insulation and vapor barrier, remove stored items, fully inspect and then properly insulate and ventilate. The foundation and structure reflect a porch that has been enclosed rather than a structure purpose built for year round use.
 The sub-floor/sheathing is decking with gaps between the boards, foundation is a short concrete block wall with a shallow "mud puddle" type footing and there is visible bounce to the floor due to long span of joisting. A contractor should be consulted to evaluate and address above concerns.

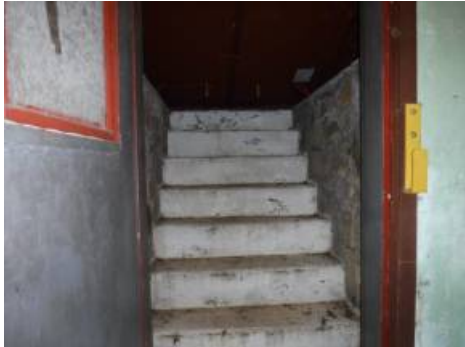
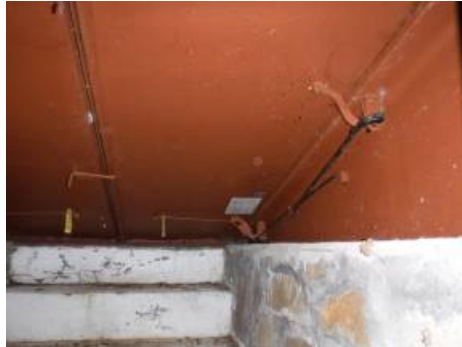
Type and Condition: *Type: Metal Bulkhead
 The bulkhead was not opened or operated due to the exterior snow build up. Paint the metal bulkhead inside and out. The stone foundation of the bulkhead should be repointed to reduce the chances of water entry. Upgrade the interior bulkhead door for improved heat savings and security.*

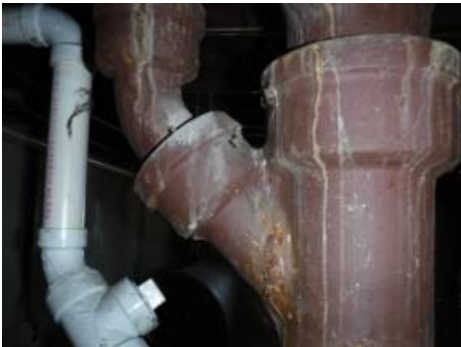
Type and Condition: **A** **B** **C** **NR** **D**
 Type: Cast Iron and PVC
 Anticipate upgrades and repairs of worn cast iron waste lines.
 Observed evidence of pitting and rust blisters.

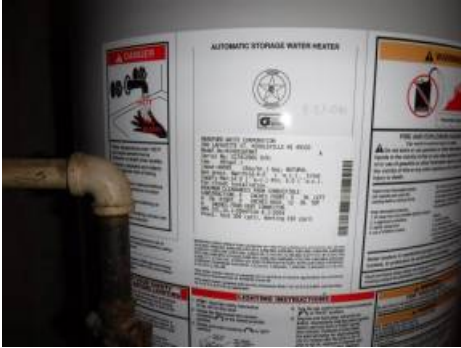
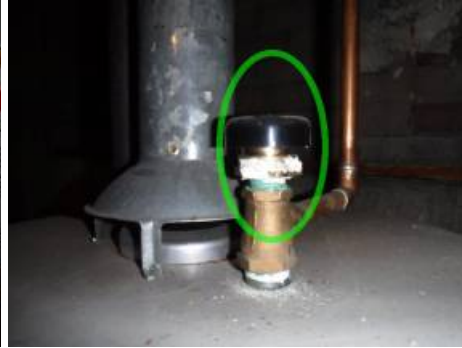
Type and Condition: *Manufacturer:* Bradford and White, *System Type:* Individual tank water heater. *Fuel Type:* Natural Gas, *Tank Size:* System Components: P&T Relief Valve, Vacuum Breaker Corrosion noted at the vacuum breaker. Repair is needed. The tank is hand marked with the install date of 04/21/06.

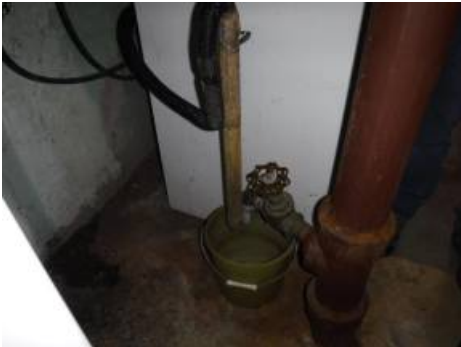
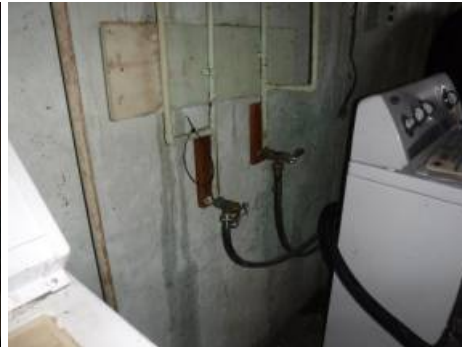
Why is there a shut off valve on the washer drain pipe, the washer hose is tightly taped into the pipe top, there is a bucket under the trap and there is signs of back up/over flow at the drain pipe. Further investigation is needed. Suggest upgrade to stainless steel (no-burst) washer feeds.

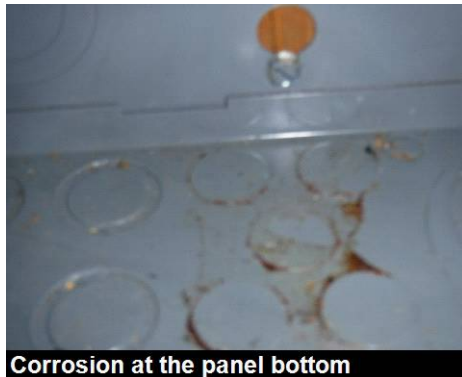
Condition: **A** **B** **C** **NR** **D** Panel Location: Basement, Devices Off: No over-current devices in the off position.
 Corrosion noted within the electrical panel, indicates that water penetration has occurred. Advise further evaluation by electrician. Corrosion may inhibit good electrical contact and moisture damage may cause breaker failure.
 Wire nut installation in the panel noted.

Corrosion at the panel bottom

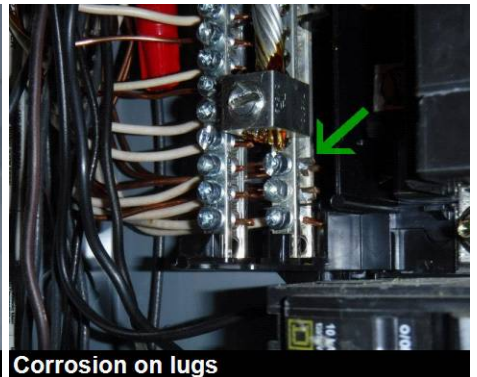
Corrosion on lugs

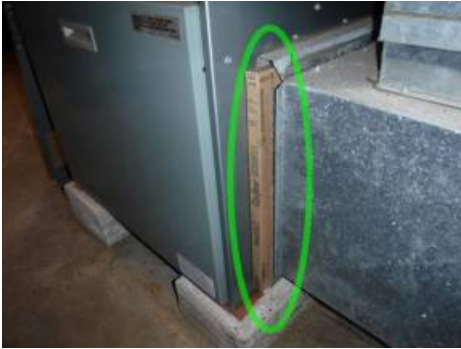
Air Filter Location: Inside return duct near heat plant. The filter slot should have a cover and be sealed to prevent air entry from the unconditioned basement.

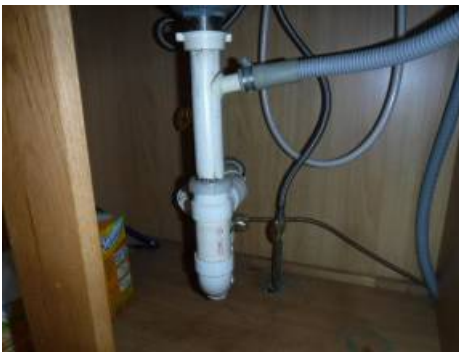
A	B	C	NR	D	
Sink:	<input type="checkbox"/>	<input checked="" type="checkbox"/>	<input type="checkbox"/>	<input type="checkbox"/>	<input checked="" type="checkbox"/>	Temp: 138F, Suggest lowering water temperature to 120F at source. The temperature recorded is at a potentially hazardous level. Staining and corrosion noted on drain and water pipes under the sink. Clean, tighten and monitor for leakage.

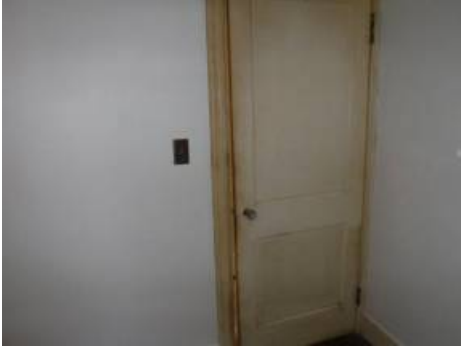
The doors throughout the house are warped, poorly fit and have poor working knobs/mechanicals.

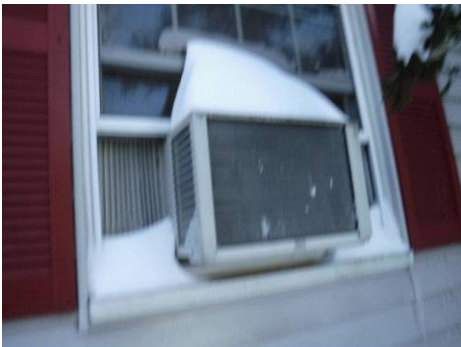
Ceiling:	<input checked="" type="checkbox"/>	<input type="checkbox"/>	<input type="checkbox"/>	<input type="checkbox"/>	<input type="checkbox"/>	Type: Gypsum.
Walls:	<input type="checkbox"/>	<input checked="" type="checkbox"/>	<input type="checkbox"/>	<input type="checkbox"/>	<input checked="" type="checkbox"/>	Type: Paneling. There is active water entry due to ice damming and a window AC unit in place.

Melting snow appears to be entering

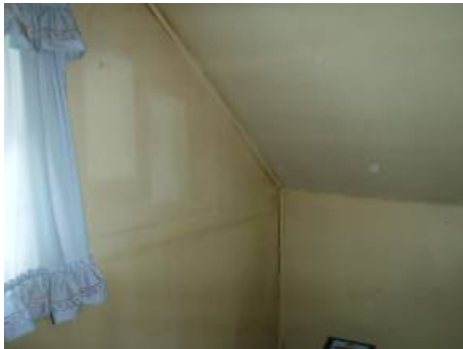
Ceiling: *Type: Gypsum*
 Rough poorly installed ceilings.

Walls: *Type: Gypsum*
 Rough and poorly installed walls.
