Home Inspection Report

Inspection Information

Inspection Date: 01/06/2018.
Client Name: [REDACTED].
[Client Email:](#) [REDACTED].
Inspector: [REDACTED].
Individuals Present: Buyer, Family and Broker.
Outside Temperature: 5-10F.
Ground Conditions: Snow Covered.
Current Weather Conditions: Clear and Cold.
Past Day Weather Conditions: Clear and Cold.
Inspection Conditions: Vacant Property.
Inspection Start Time: 9:00 AM.
Inspection Finish Time: 1:30 PM.
Inspection Type and Cost: Single Family Home Inspection: \$ [REDACTED].
Radon Test: Radon Vials: [REDACTED], Vial Numbers: [REDACTED].
Other Services Provided: None.
TOTAL AMOUNT DUE: \$ [REDACTED].

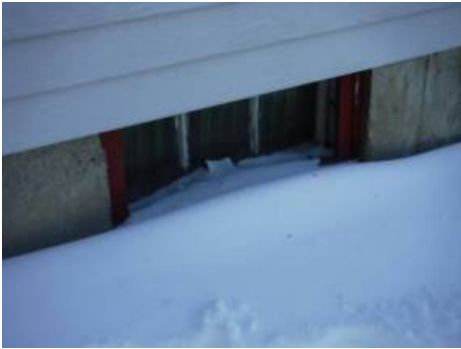
need repair, prep and paint or upgrade.

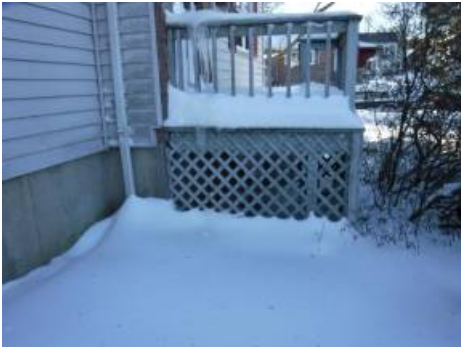
Snow cover limits inspection.

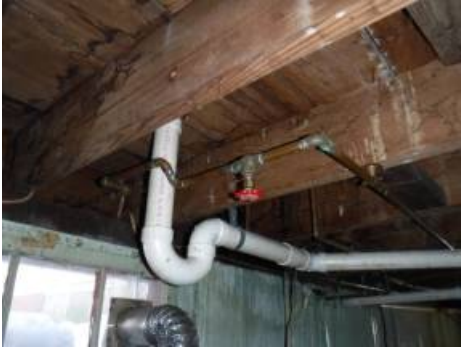
Type and Condition: **A** **B** **C** **NR** **D**
 Type: Cast Iron and PVC
 Anticipate upgrades and repairs of worn cast iron waste lines.
 Observed evidence of pitting and rust blisters.

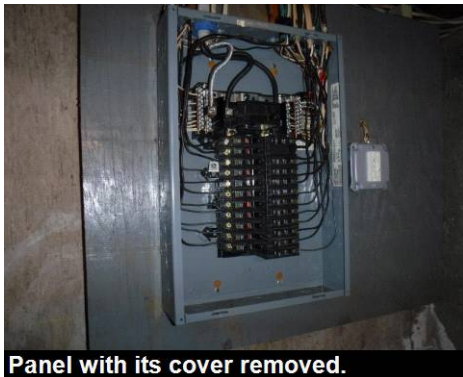
Condition: **A** **B** **C** **NR** **D** Panel Location: Basement, Devices Off: No over-current devices in the off position.
 Corrosion noted within the electrical panel, indicates that water penetration has occurred. Advise further evaluation by electrician. Corrosion may inhibit good electrical contact and moisture damage may cause breaker failure.
 Wire nut installation in the panel noted.

Panel with its cover removed.
